UNDERWATER BRIDGE INSPECTION REPORT

STRUCTURE NO. 05521
CSAH NO. 2
OVER THE
MISSISSIPPI RIVER
DISTRICT 3 - BENTON COUNTY

PREPARED FOR THE
MINNESOTA DEPARTMENT OF TRANSPORTATION
BY
COLLINS ENGINEERS, INC.
JOB NO. 3512 (CEI 80)

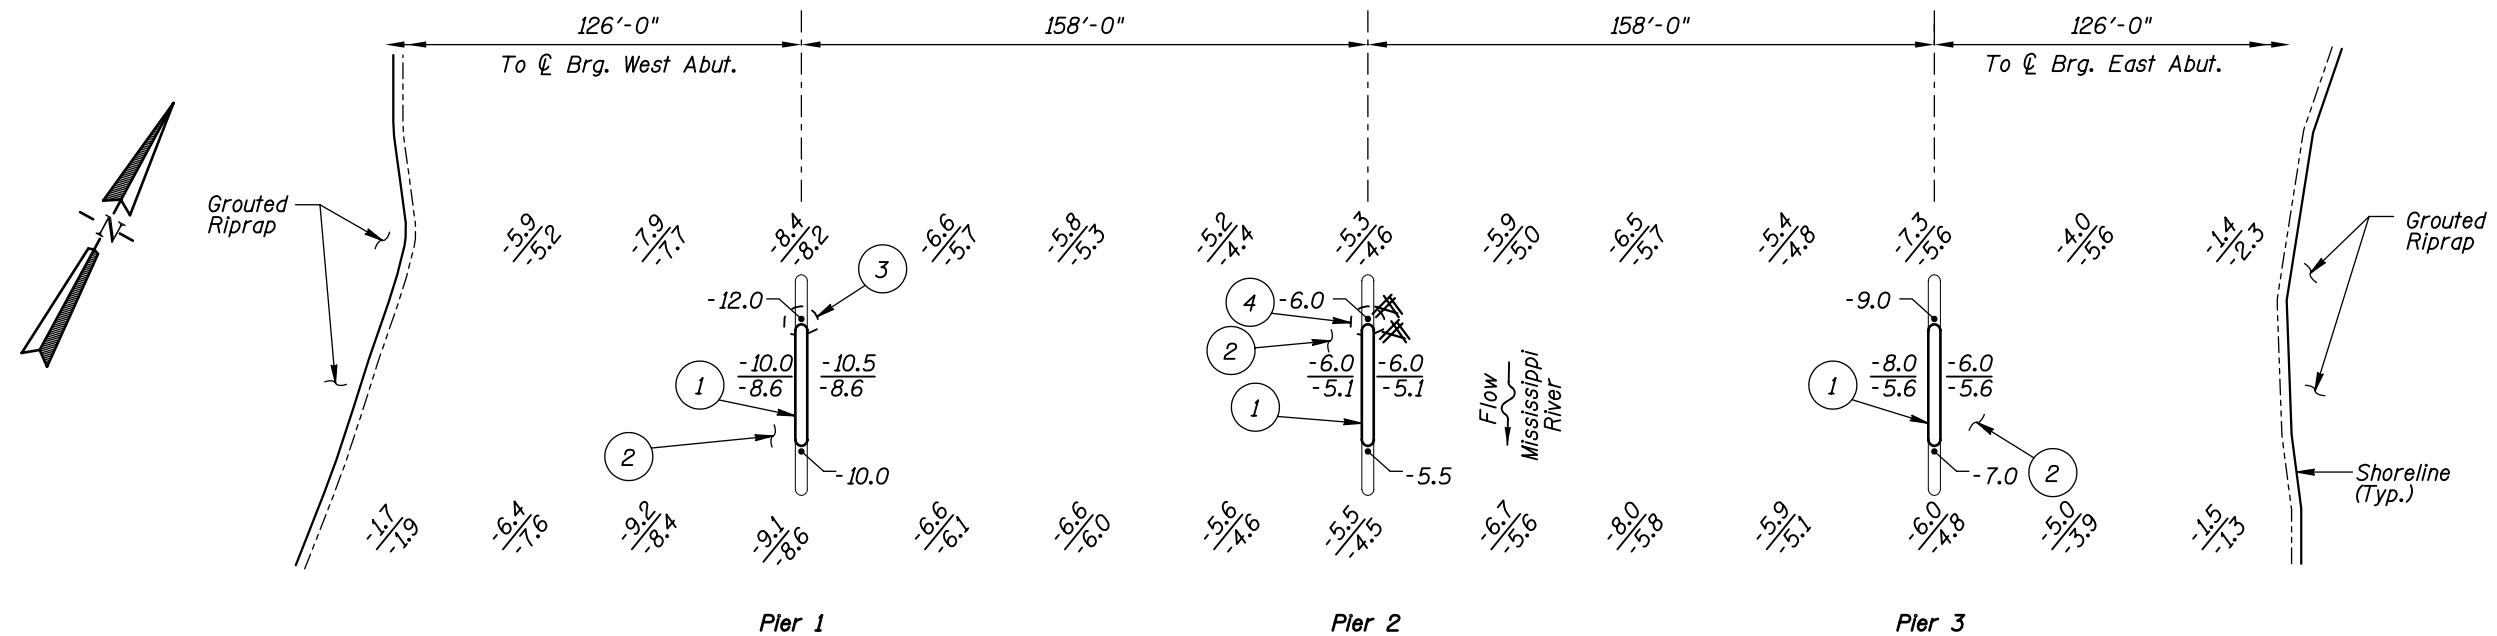
| Code: 35120080 | | Figure No.: 1 |

- 1 A band of minor scaling was observed from 4 feet above to 1 foot below the waterline with typical penetrations of 1/8 inch and a maximum penetration of 1/4 inch.
- 2 The channel bottom consisted of sandy gravel and up to 5-inch-diameter cobbles with a maximum probe rod penetration of 4 inches.
- 3 A 4-foot-radius, 1.5-foot-deep sour pocket was observed at the upstream end of Pier 1.
- 4 A 2-foot-radius, 6-inch-deep scour pocket with a minor accumulation of timber debris was observed at the upstream end of Pier 2.

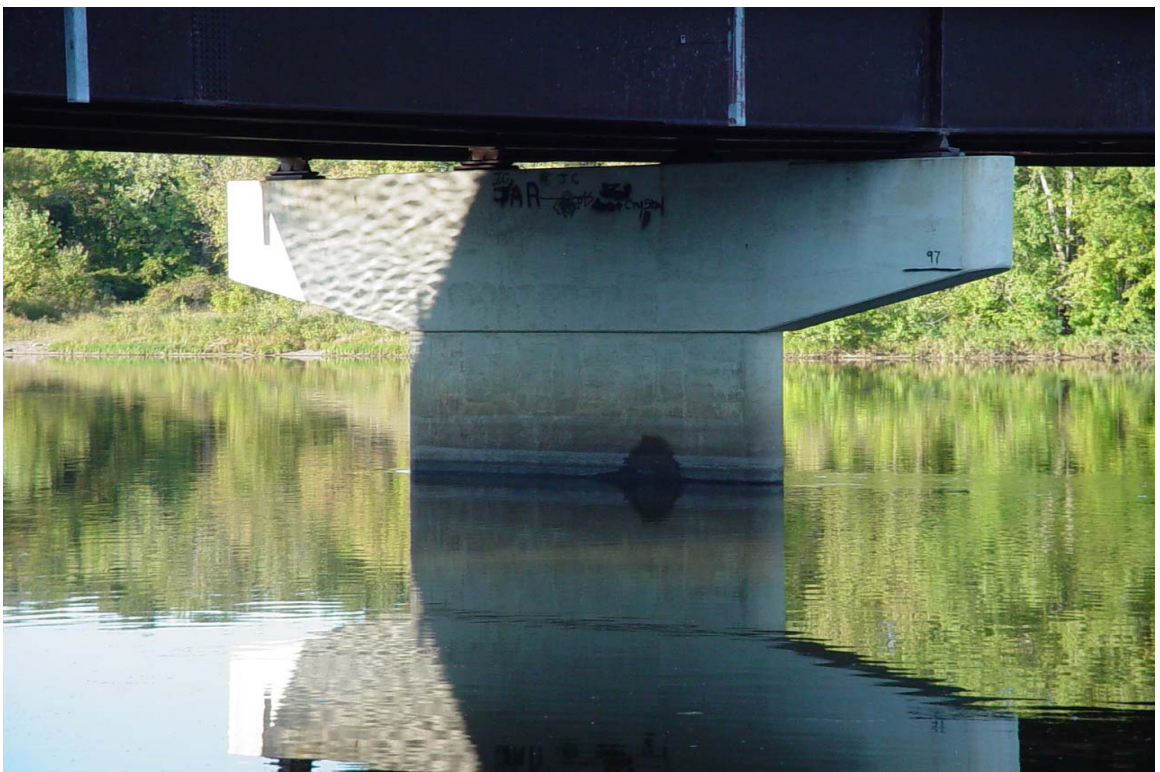
- (A) A band of minor scaling was observed from 4 feet above to 1 foot below the waterline with typical penetrations of 1/8 inch and a maximum penetration of 1/4 inch.
- (B) A 4-foot-radius by 1.5-foot-deep scour depression was observed at the upstream end of Pier 1, and a 2-foot-radius by 6-inch-deep scour depression with a minor accumulation of timber debris was observed at the upstream end of Pier 2.

Photograph 2. View of Pier 1, Looking North.

- (A) Reinspect the submerged substructure units at the normal maximum recommended (NBIS) interval of five (5) years.

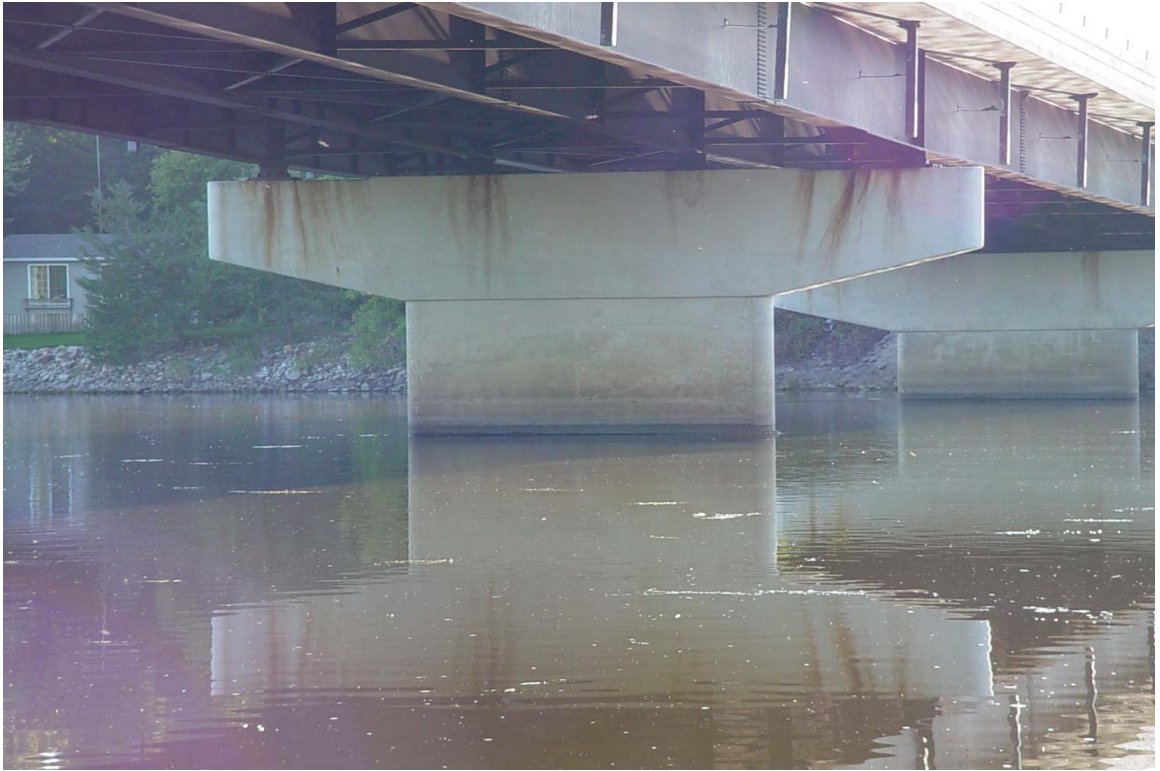
Photograph 3. View of Pier 2, Looking South.

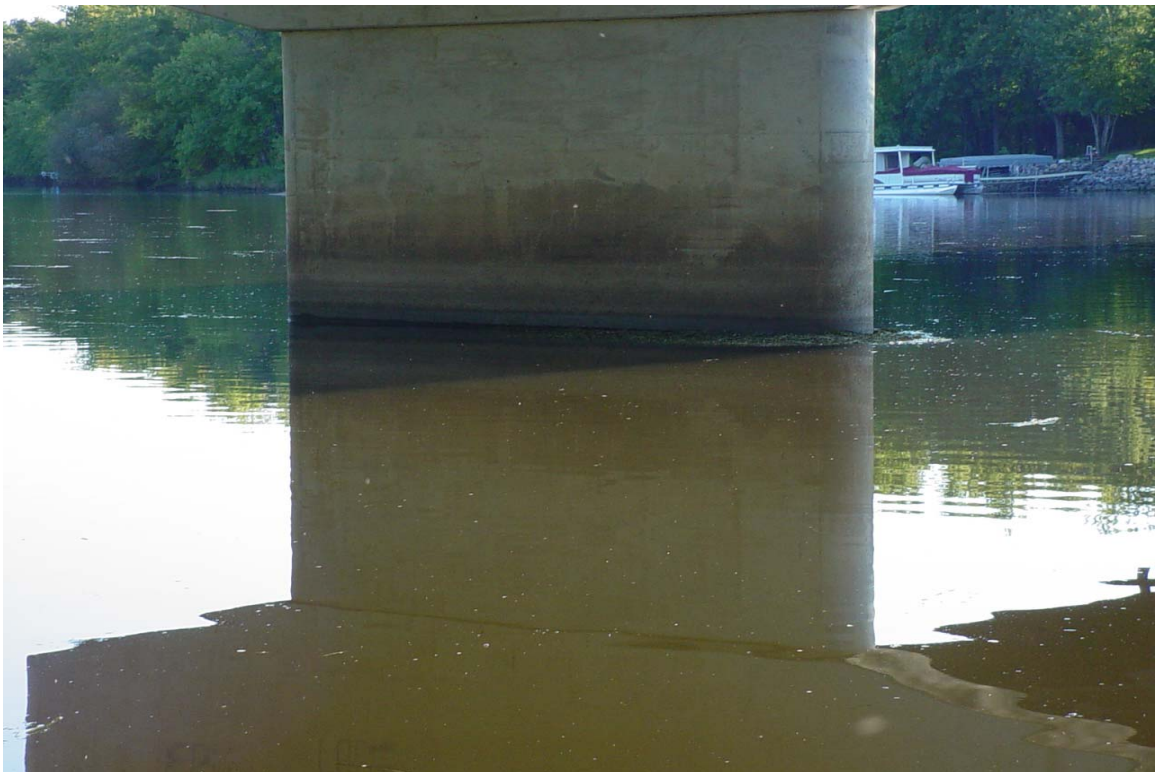
Photograph 4. View of Pier 3, Looking South.
